# PROPERTY INSPECTION REPORT

123 Main St.  
Anytown, CO

July 1, 2007

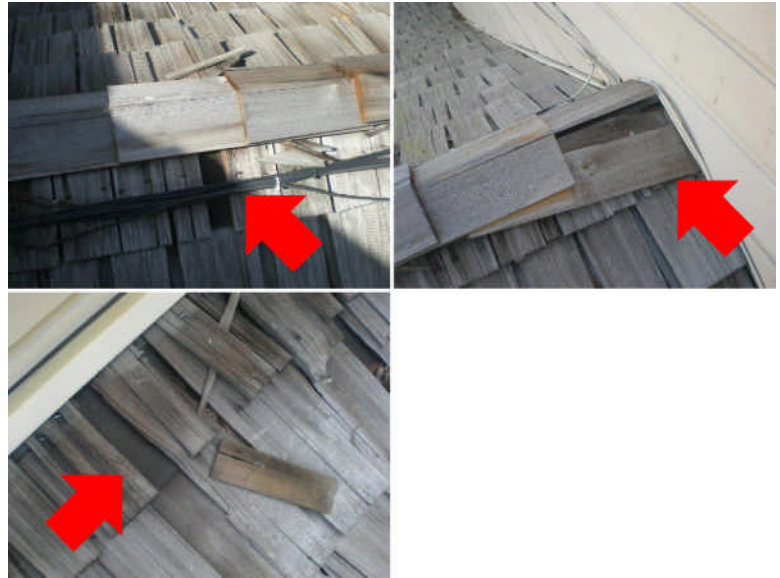
5.7 Condition of wood shakes/ shingles:

**Attention:** Cracking noted. Missing pieces and/or shingles noted. Splitting of shingles noted. Hip and ridge pieces falling apart noted.

1. **Attention:** Cracking noted. Missing pieces and/or shingles noted. Splitting of shingles noted. Hip and ridge pieces falling apart noted.

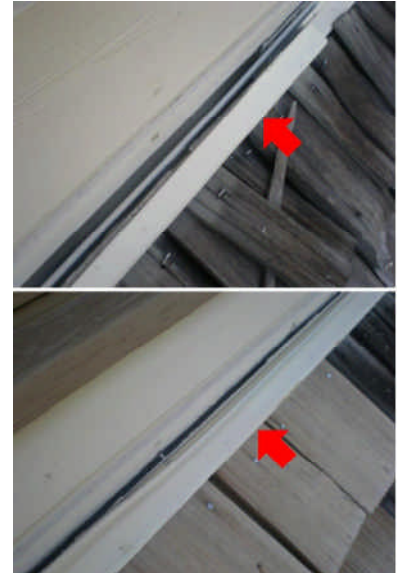
5.8 Flashing:

**Attention:** Re-secure wall roof flashing. Located at south side of roof.

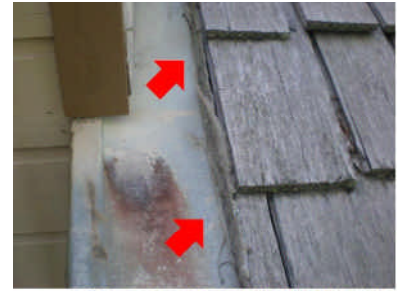
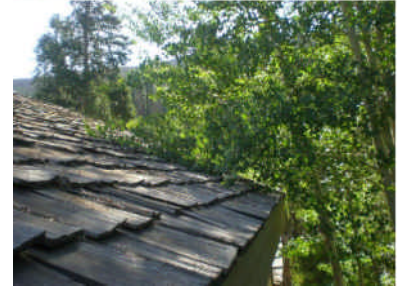
**5.9 Overall condition of the roof:**

**Attention:** Contact licensed qualified roofing contractor. Roof needs small repair. Also, areas of caulking need to be re-sealed. Cut back trees so they are not in contact with the roof as they can cause damage.

3. **Attention:** Contact licensed qualified roofing contractor. Roof needs small repair. Also, areas of caulking need to be re-sealed.

Cut back trees so they are not in contact with the roof as they can cause damage.

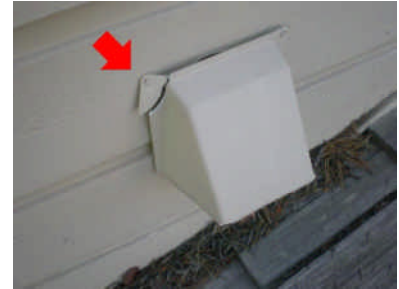
**5.10 Additional Pictures:**

**Attention:** Replace broken vent cover on exterior at north side roof.

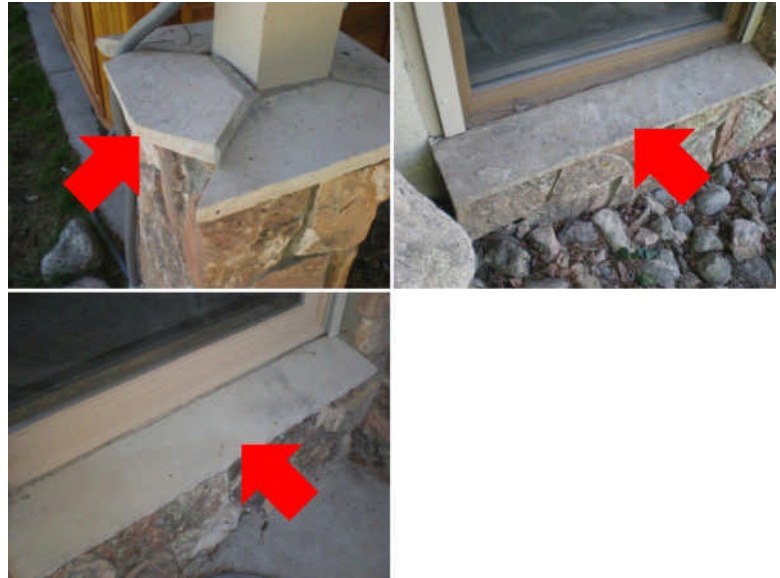
**5.16 Condition of Stone:**

**Attention:** At back patio. Broken and unsecured rock at deck post. Unsecured rock sill at window near back steps and on north side of the house.

4. **Attention:** At back patio. Broken and unsecured rock at deck post. Unsecured rock sill at window near back steps and on

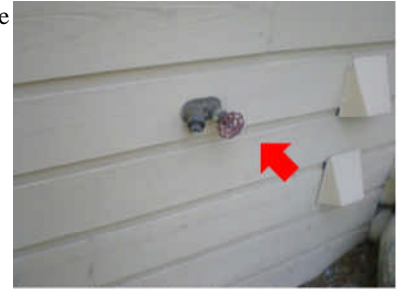
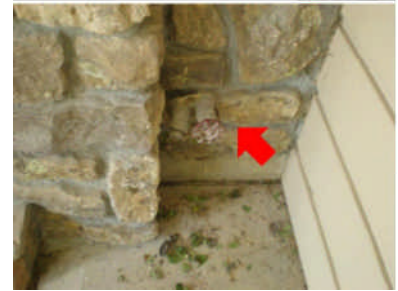
### 5.23 Condition of front faucet:

**Attention:** Could not get water to flow at faucet next to garage and on south side of the house.

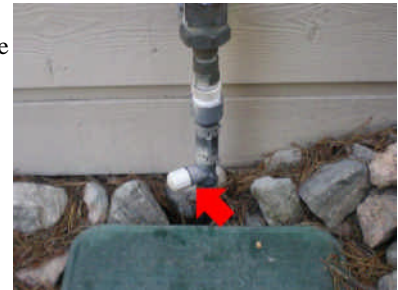
### 5.25 Lawn Sprinkler System:

Inspection of the installed lawn sprinkler is beyond the scope of this inspection. Hire lawn sprinkler company for inspection if concerned. **Attention:** Leaky pipe was noticed. Repair as necessary.

7. Inspection of the installed lawn sprinkler is beyond the scope of this inspection. Hire lawn sprinkler company for inspection if concerned. **Attention:** Leaky pipe was noticed. Repair as necessary.

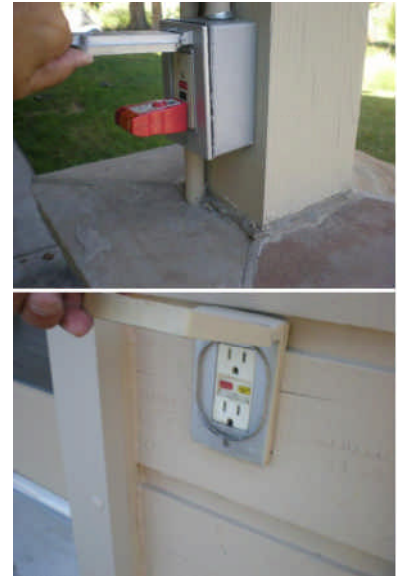
### 5.29 Rear Outlet(s)

**Action:** 2 GFCI outlets did not interrupt the circuit when tested.

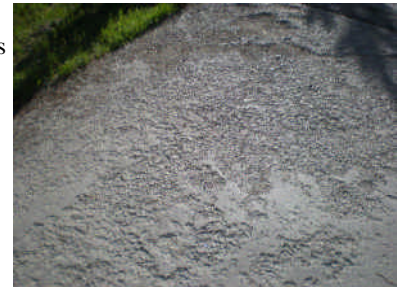
#### 5.33 Driveway Condition:

**Attention** - The driveway needs attention and minor repair to prevent further deterioration. Spalling - Spalling is when the surface is flaking off. While this is not necessarily a fatal condition, it may worsen over time. At some point you may want to replace sections for aesthetic purposes. Doing a top coat sealer can help prevent further deterioration.

10. **Attention** - The driveway needs attention and minor repair to prevent further deterioration. Spalling - Spalling is when the surface is flaking off. While this is not necessarily a fatal condition, it may worsen over time. At some point you may want to replace sections for aesthetic purposes. Doing a top coat sealer can help prevent further deterioration.

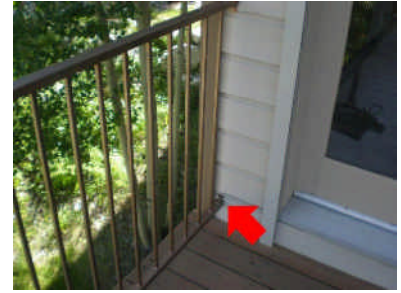
### 5.40 Deck Railings:

**Attention** - The railings are in place however some repair or upgrade is recommended. Re Secure all deck railings. Some are looser than others.

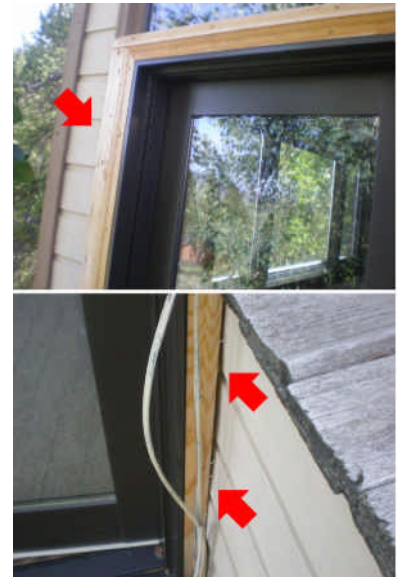
### 5.46 Comments:

**Attention:** The casing around the door on the exterior needs to be painted or stained. Right now, it is unfinished wood. Also, around the casing needs to be caulked and sealed.

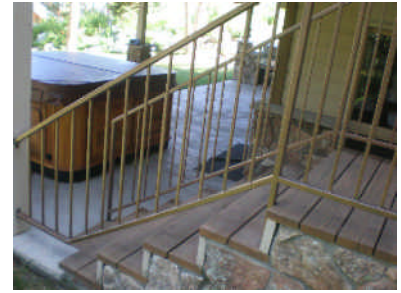
#### 5.48 Deck Railings:

**Attention** - The railings are in place however some repair or upgrade is recommended. Handrails are loose. Re-secure.

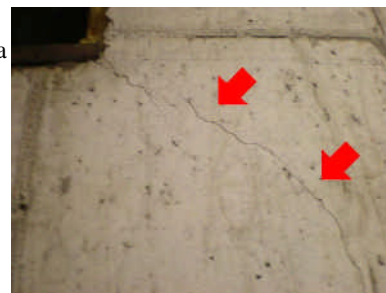
### 7.14 Conditions Noted in Exterior Walls, Interior View:

Shrinkage cracking was noted on at least one wall. Shrinkage cracking is the result of the evaporating of moisture in the concrete walls. This generally is not a cause for concern as all concrete shrinks. Should any of these cracks begin to grow, then further attention and evaluation would be recommended.

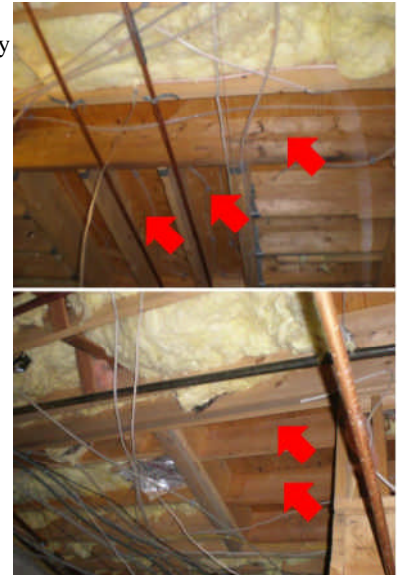
Location of insulation: Ceiling. Walls. Type: Fiberglass batts. Condition:

**Attention:** Some areas of the ceiling are not insulated. Crawlspace seemed fairly warm but adding some insulation will help with energy efficiency.

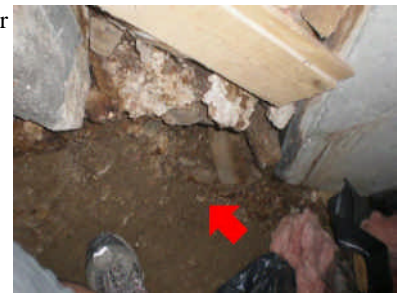
**7.22 Evidence of Water Entry:**

**Attention:** Small amount of ground water noticed under south side wall exterior wall. I would say it falls into the "acceptable" category for ground moisture. Monitor crawlspace during different times of the year to see if water becomes excessive.

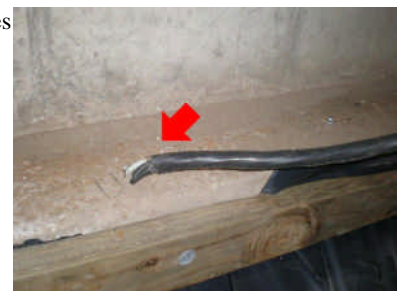
**7.23 Lighting and Wiring:**

**Attention:** There is some unterminated wiring on south end of crawlspace. Does not appear to be "hot", but have electrician properly terminate or remove wiring.

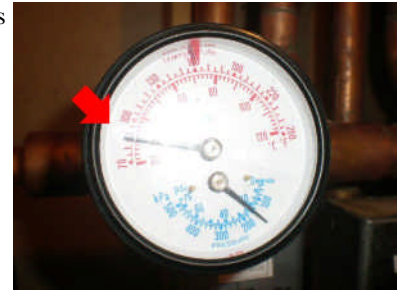
#### 8.15 Temperature:

**Attention:** The temp gauge inside the cabinet read was at 180 degrees, which is where it should be. The temp gauge on the pipes near some of the zone valves was only reading about 85 degrees. This needs to be looked at.

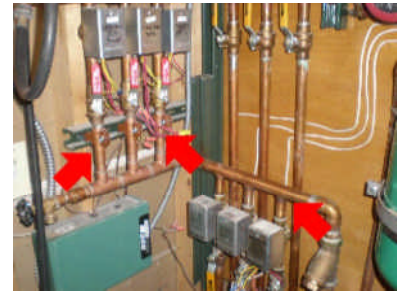
#### 8.19 Circulating pump(s)

**Attention:** Some of the zones did not appear to be circulating. The pipes associated with that pump did not get hot indicating the hot water may not be circulating through the pump. Recommend having all circulating pumps checks by radiant heat specialist.

Recommend a full inspection and servicing of the heating system by a qualified radiant heat contractor.

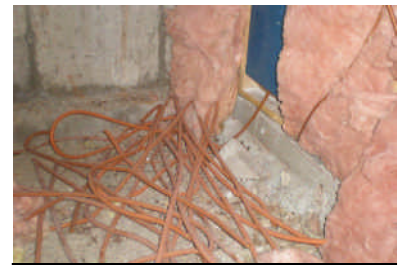
#### 8.21 Radiant Heat Tubing:

**Attention:** The installed tubing is Wirsbo He Pex which is correct. In the crawlspace, there is some old Entran tubing which had major issues and was known for failure. It appears like the Entran tubing has been removed, but check with seller as to a complete history of the Entran tubing and make sure it was ALL replaced.

Old Entran tubing on ground in crawls

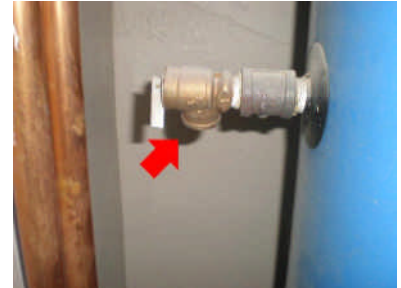
**9.33 Safety Overflow Pipe:**

**Action:** There is no overflow pipe installed. For safety reasons, immediate installation is needed to help minimize the possibility of serious injury.

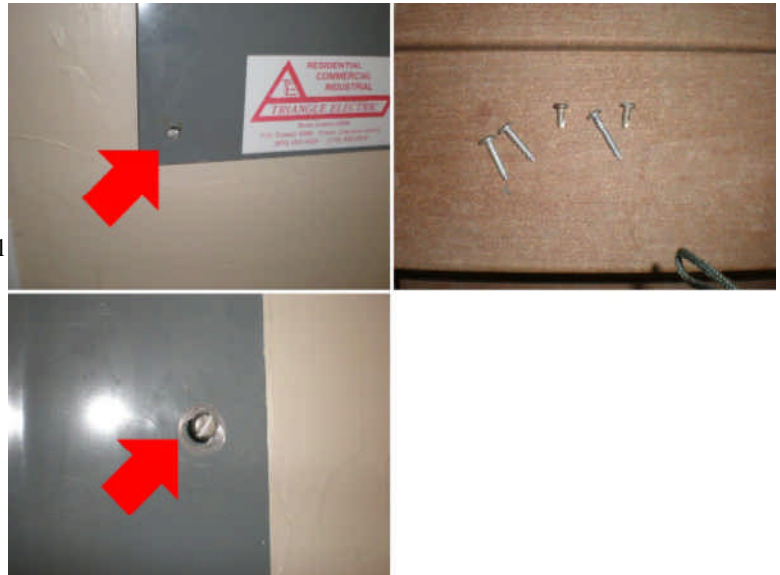
### 10.12 Panel Condition:

**Action** - The power panel, as a container for safely covering circuitry and components, requires immediate action to minimize the possibility of an electrical shock.

The panel cover is missing a screw and some of the other screws are the wrong size, not properly supporting the panel cover and one is a pointed tip screw. Panel screws should be flat tipped so that no wires get pierced when cover is removed and replaced. Recommend replacing all incorrect screws with proper panel screws.

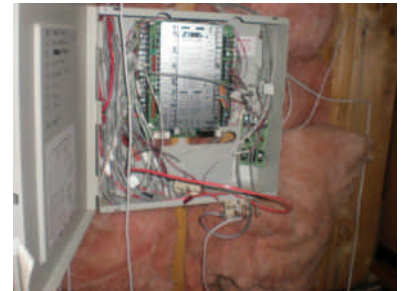
**Attention:** It does appear that the wiring may need attention. Panel door was open and loose wires and unterminated wires were noticed. Recommend contacting security company for full evaluation of the security system. Alarm company is Superior Alarm Summit 970-468-0276

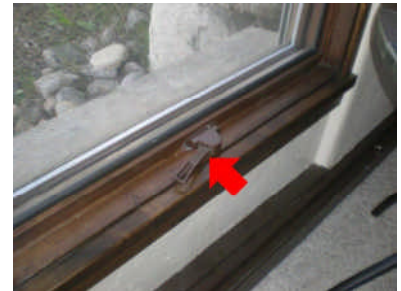
**14.68 Windows:**

**Attention:** Small window on the north wall was stuck shut. Could not get window to open.

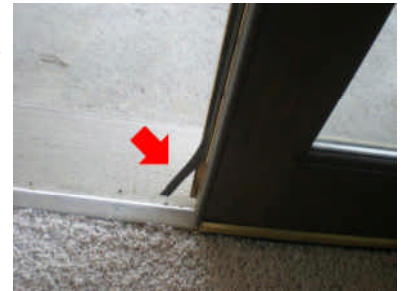
**14.71 Exterior door(s)**

Satisfactory - Door(s) to this room is satisfactory. **Attention** - The outside entry door to this room needs some minor adjustment or repair. Door on the right has a small piece of weather stripping that needs to be re-attached.

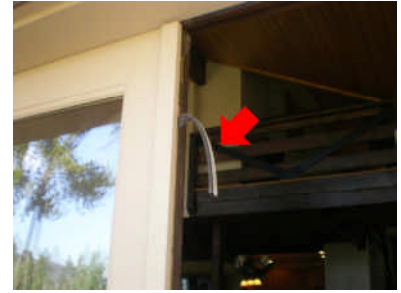
14.80 Exterior door(s)

**Attention** - The outside entry door to this room needs some minor adjustment or repair. Repair/replace weather stripping on left side door.
